S. HRG. 112–170

THE WIND RIVER IRRIGATION PROJECT—ISSUES ARISING FROM AND CONTRIBUTING TO DEFERRED MAINTENANCE AND OTHER PROJECT MANAGEMENT PROBLEMS

FIELD HEARING

COMMITTEE ON INDIAN AFFAIRS
UNITED STATES SENATE

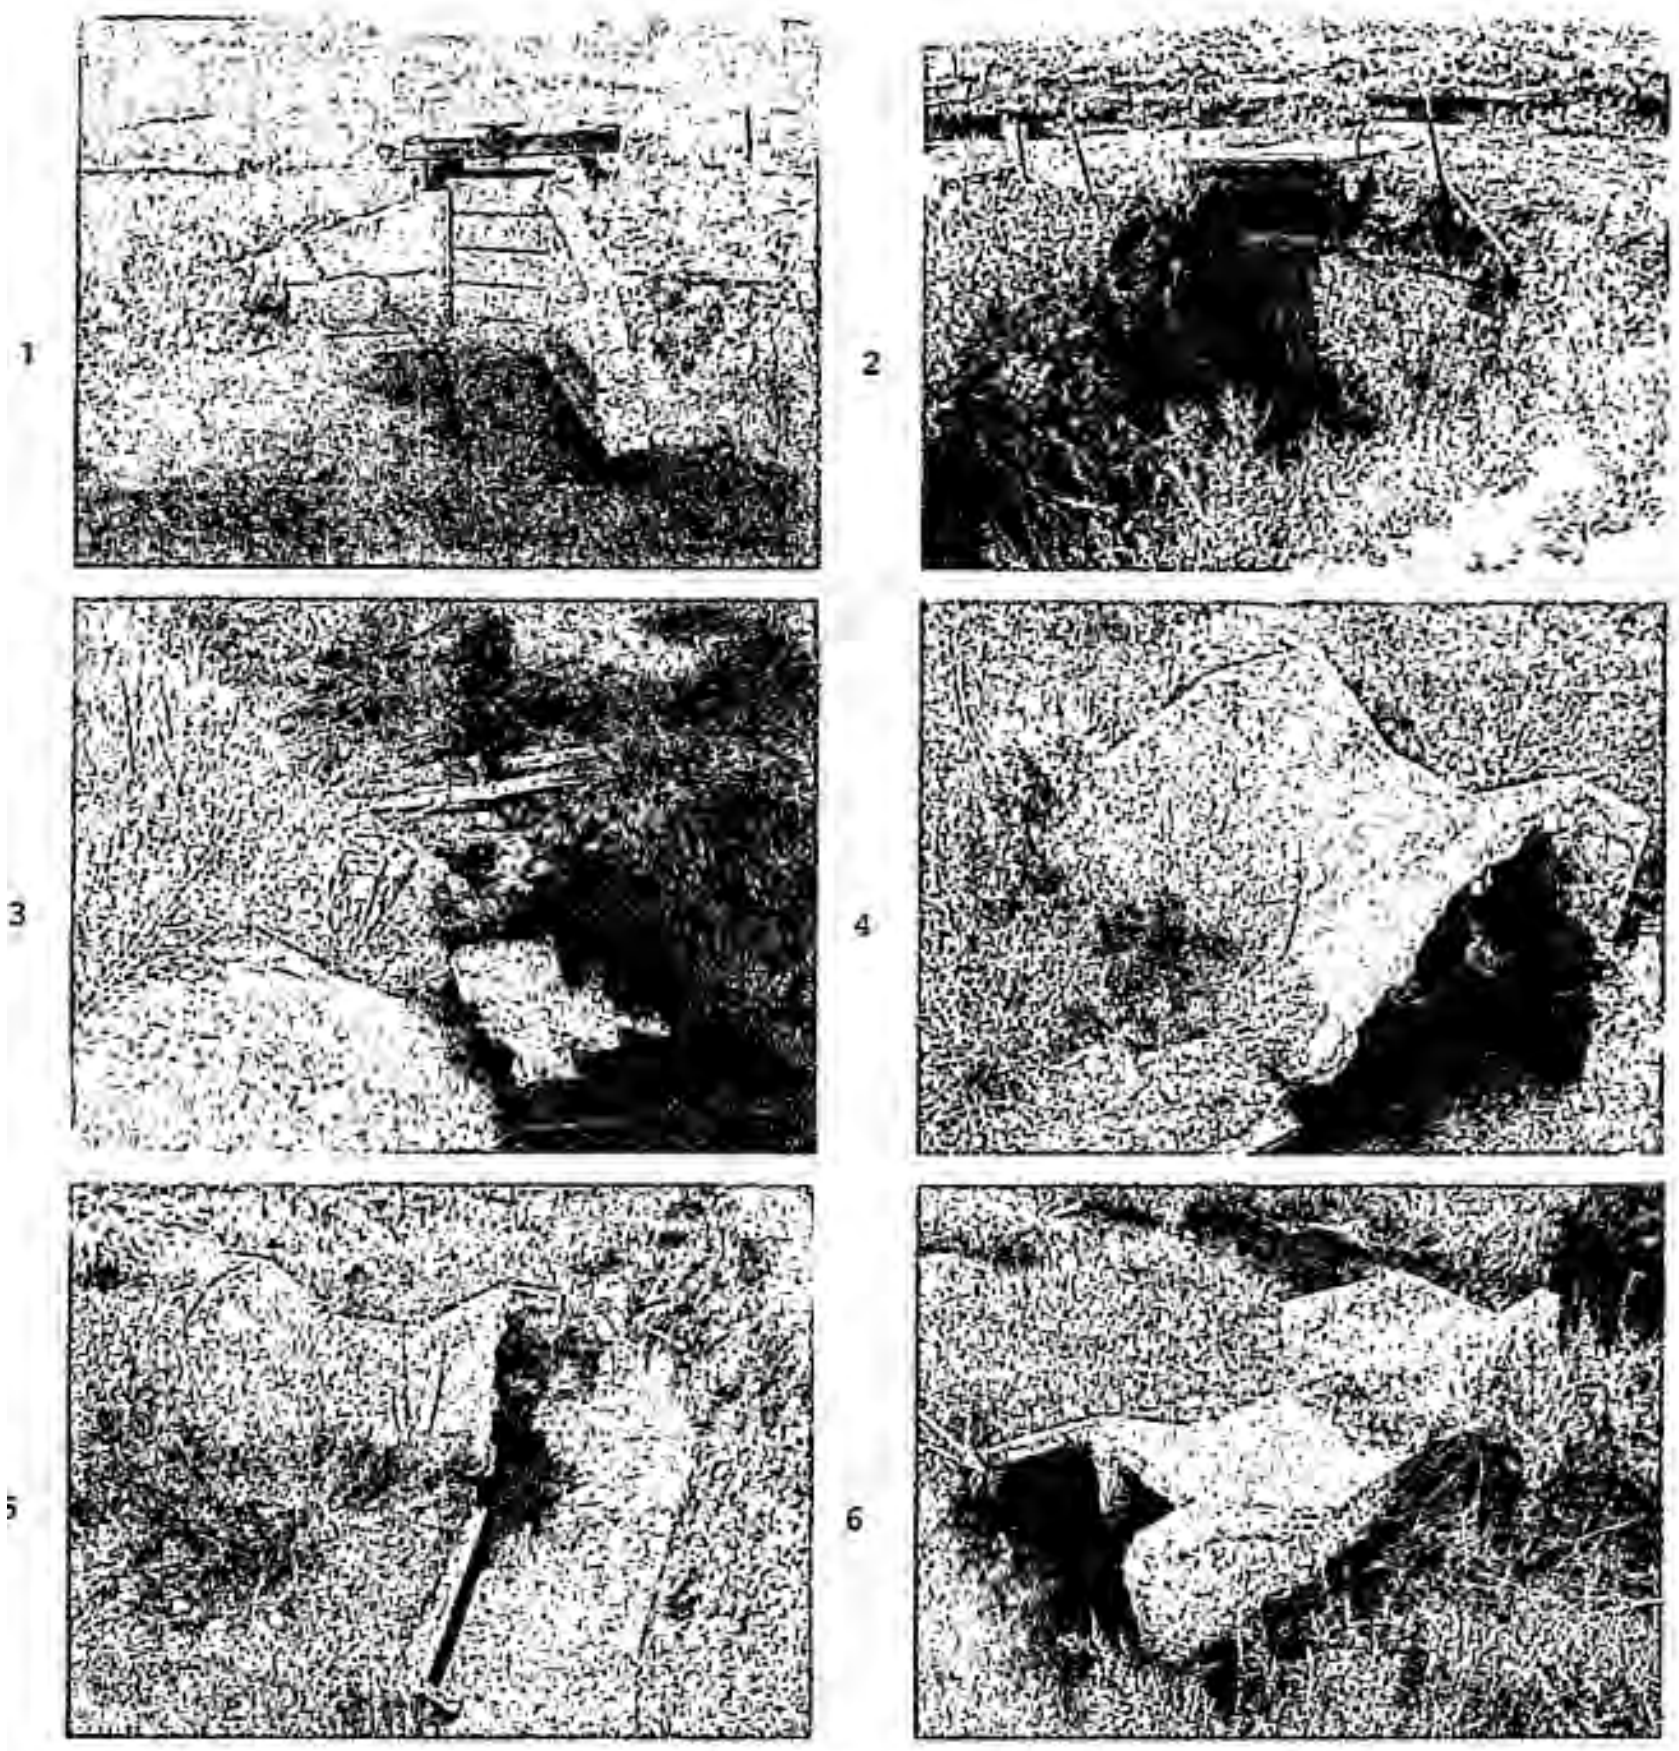
39C/Ray Canal Lateral Fort Washakie area

- Current condition: A non-functioning diversion due to canal eroding down and away from the structure. A temporary 24 inch turn-out has been installed to deliver irrigation water around existing structure. A rock check is existing , however it is in-effective as a water back-check.

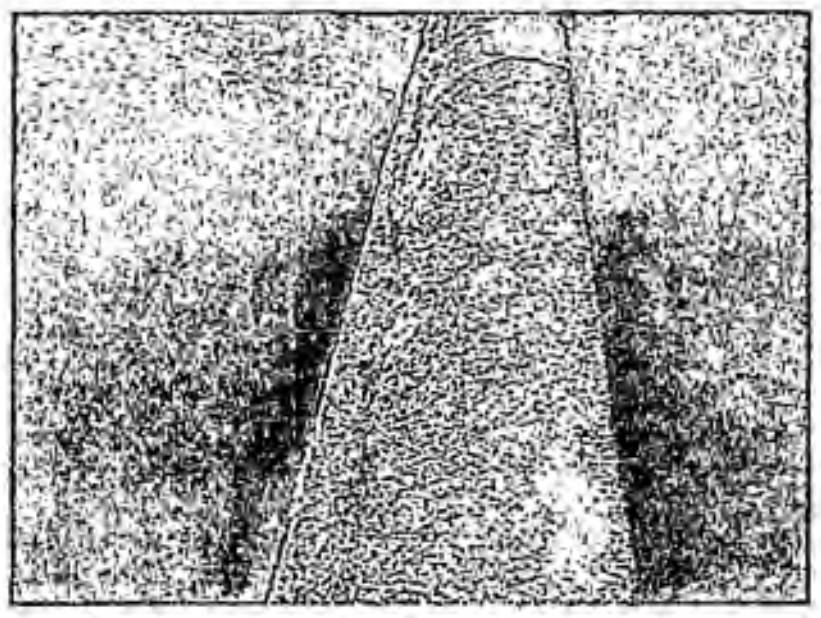
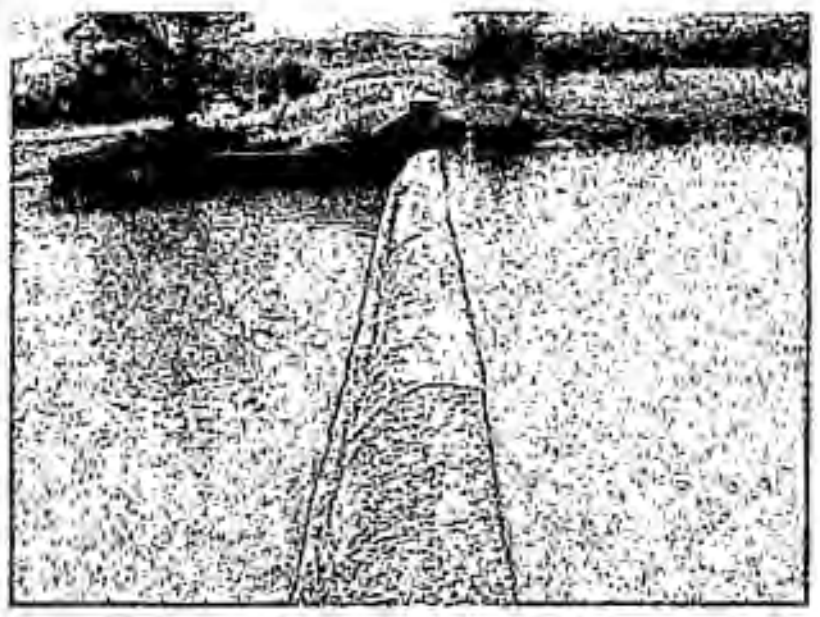
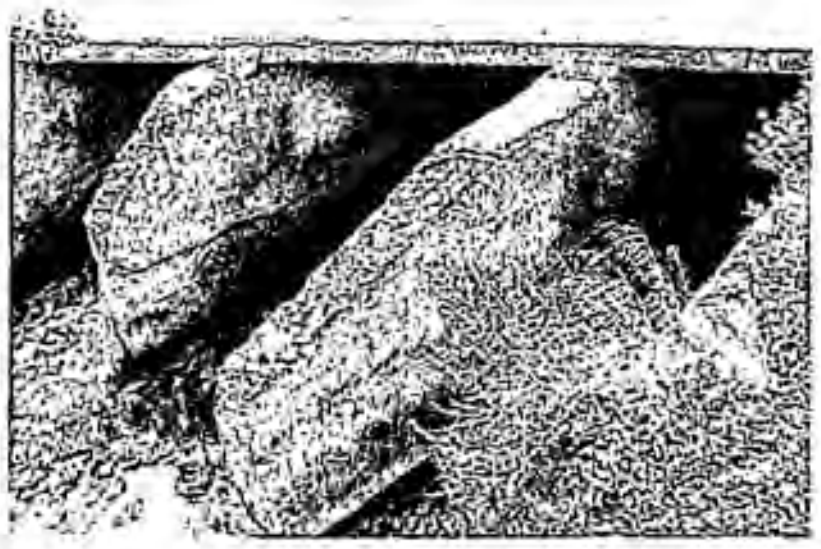
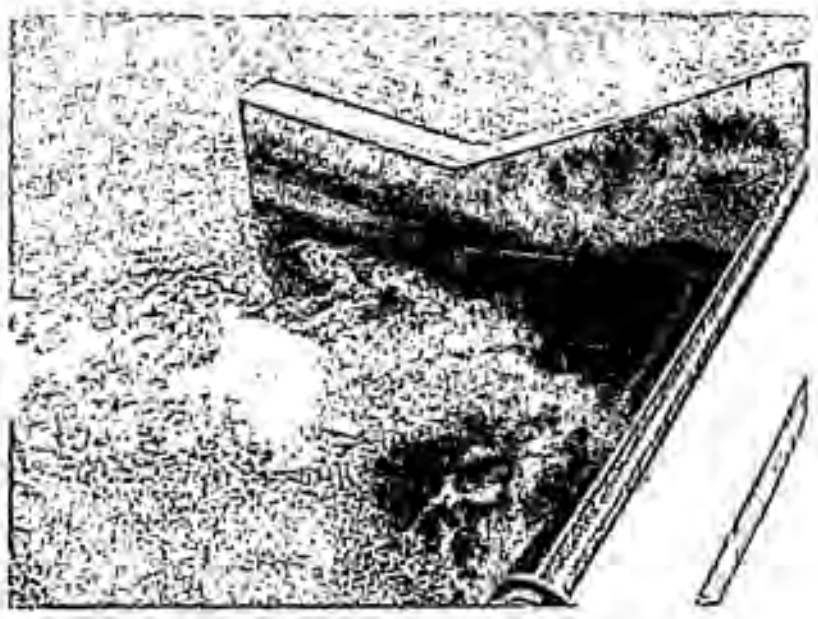
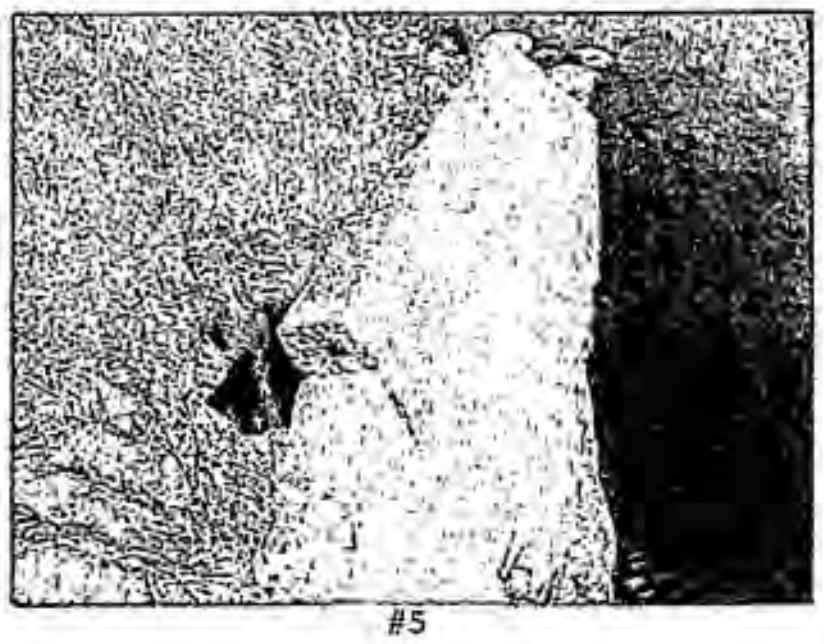
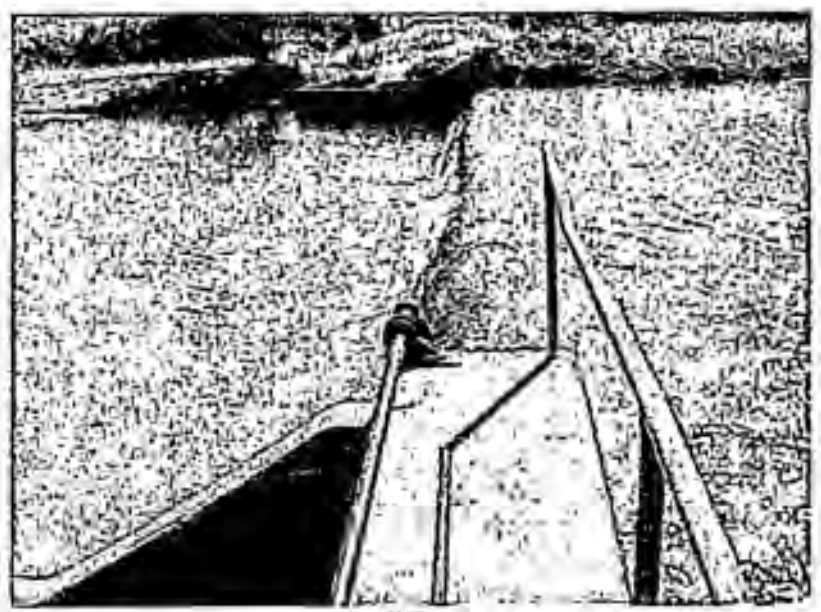
Sub-Agency Canal 17mile area
Photo #1

- Photos: [6 total] All deterioration.

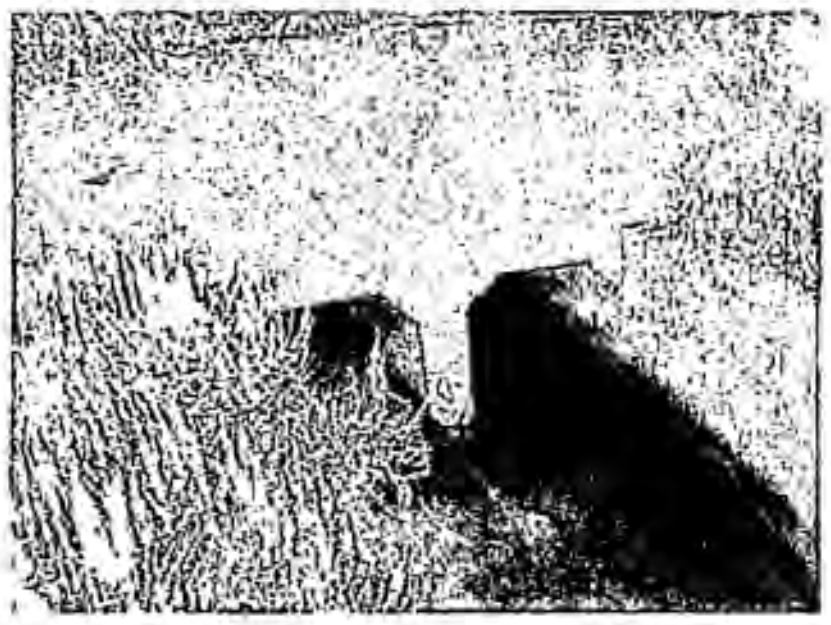
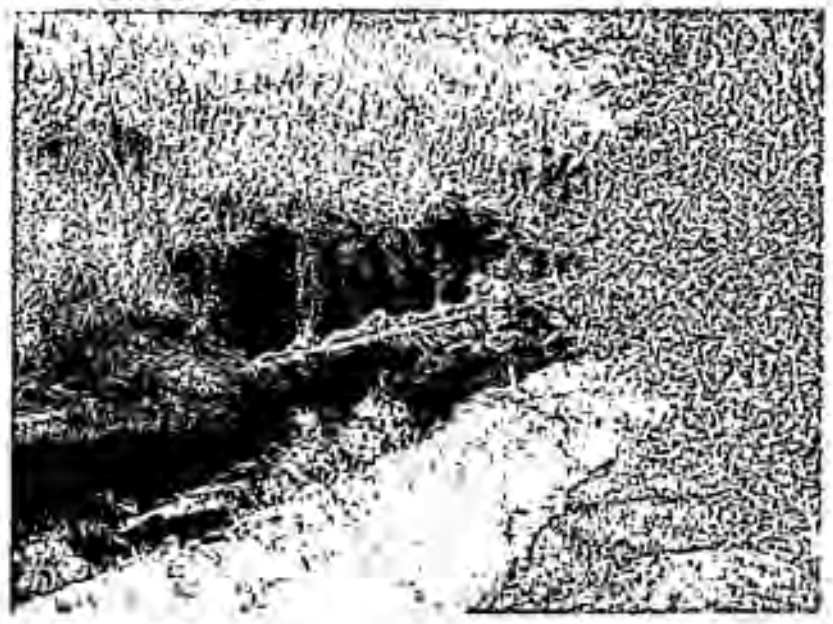
14B Diversion Structure w/ Chute drop
Photo #1

- Current Condition: The diversion structure and metal gates are aged. The irrigation water delivery is thru 2 metal slide gates measuring 2ft x 2ft. The attached chute drop is failing. There is water flowing under the concrete. The chute is washing out and breaking into sections. Length is 154 ft long.

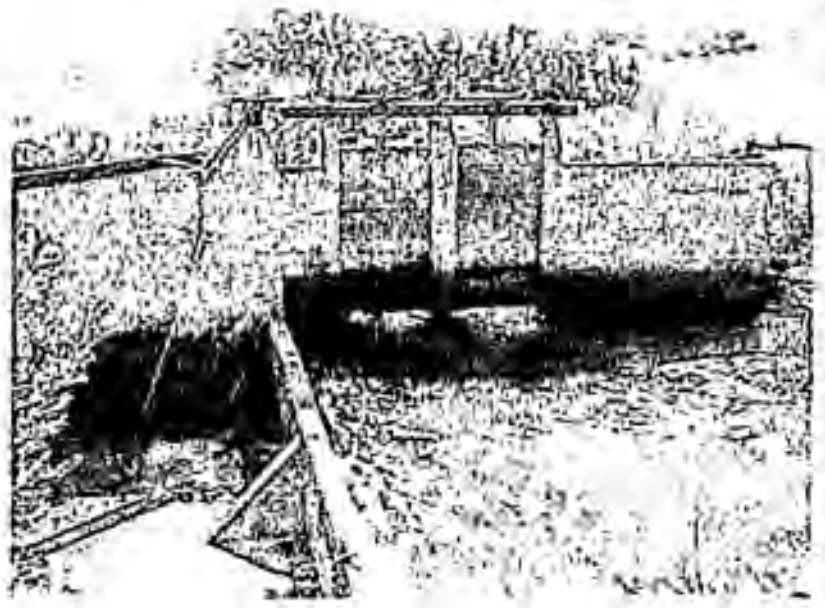
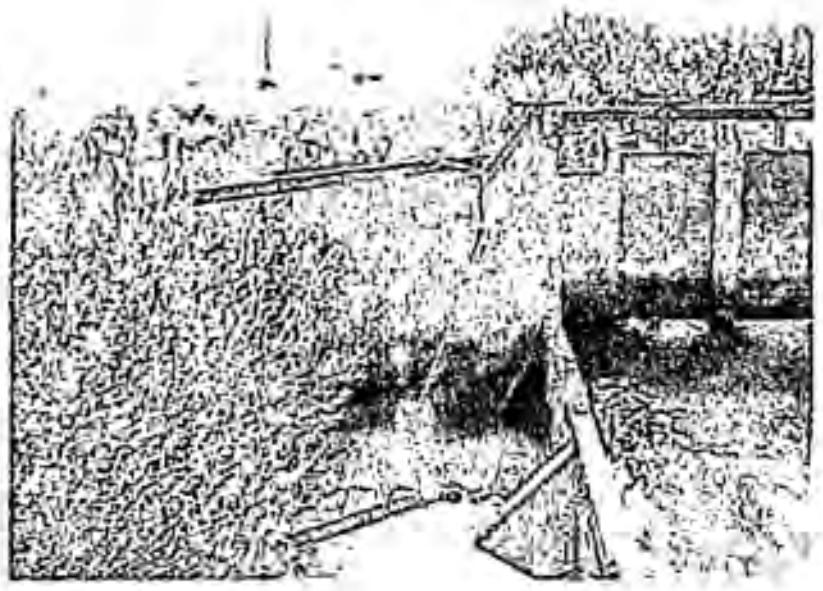
Meadow Creek Diversion
Crowheart area

- Current Condition: Present structure is servicable but aged. It has wooden gates, the concrete has deteriorated below the water surface. Especially at the gate slide bottoms. To shut leaks, the project personnel has to sandbag or mud in the bottoms with earth moving machinery. This headgate has very limited access for the ditchrider as the footbridge was dismantled. All gate lifting hardware are deteriorated and the slide rails rusted away.

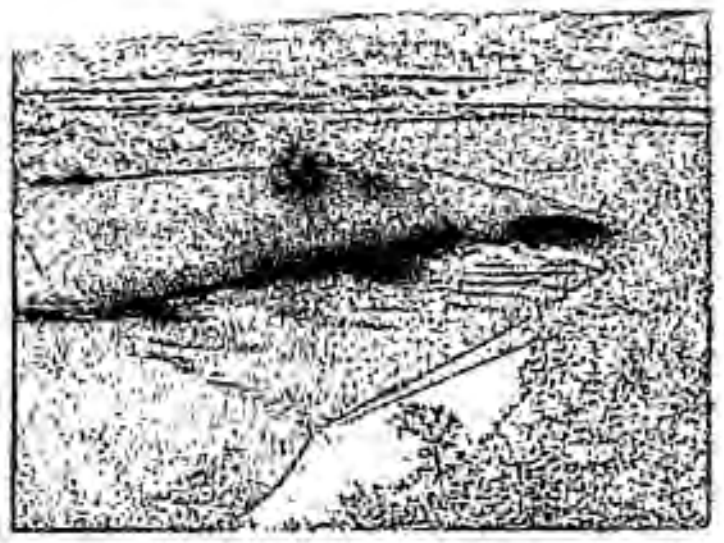
2

- Current Condition: Poor, caused by natural occurring attrition. Concrete degradation caused by; A) Cavitation. B) Abrasion, which is indicated by exposed re-bar. East side Velocity Diffusers wearing out. [Dentates]

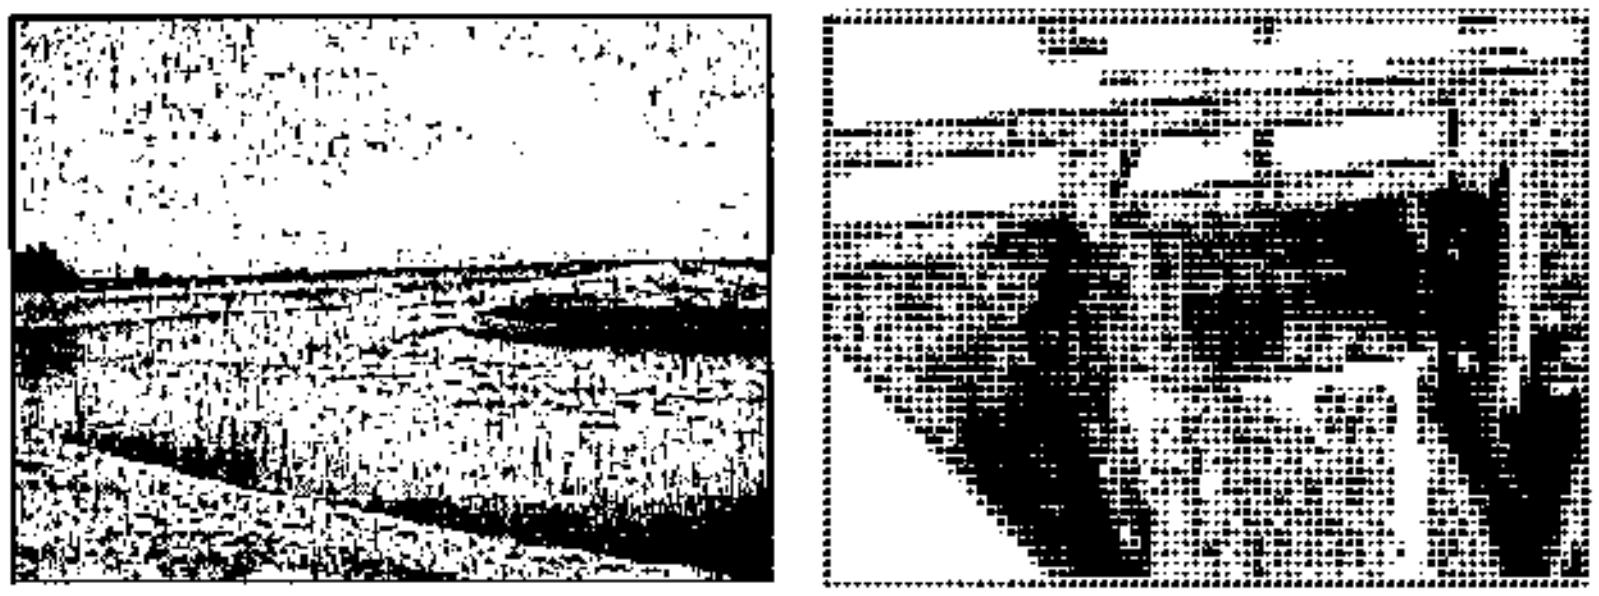
Figure 9: Pictures of the Colorado River Irrigation Project (June 2005)

Concrete-lined Irrigation Canal

Leaking Check Gate

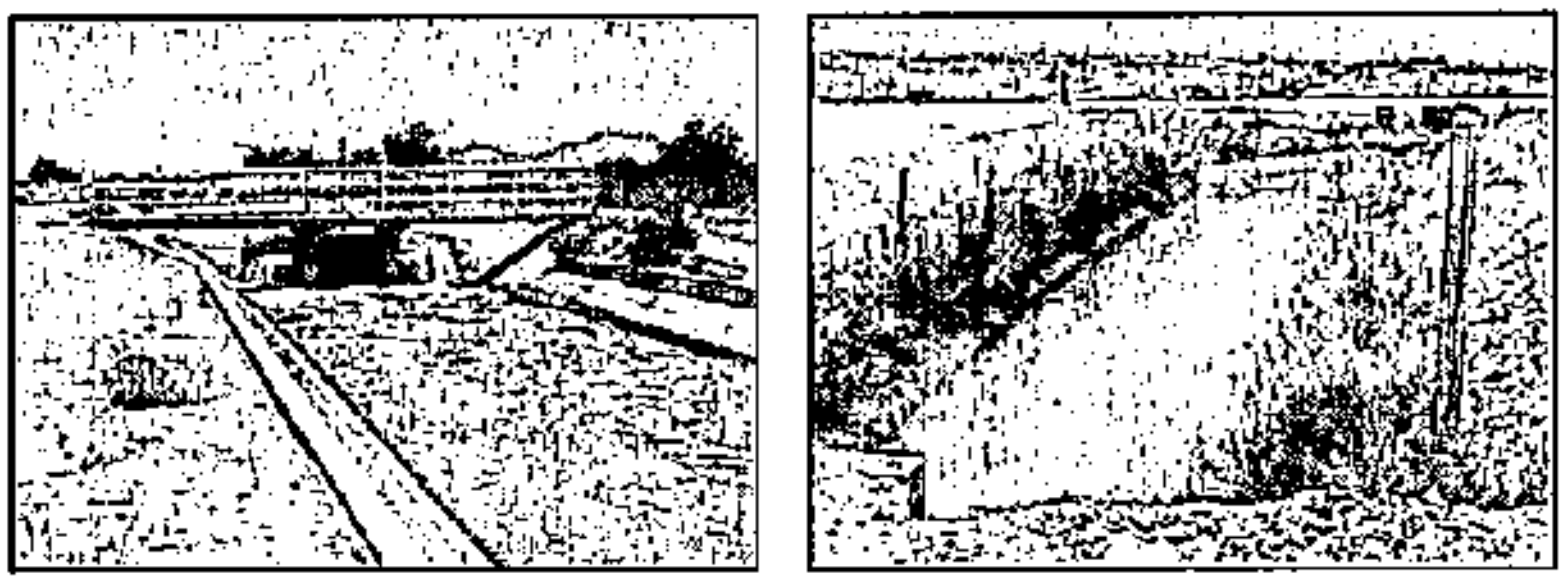
Figure 13: Pictures of the San Carlos Indian Works Irrigation Project (June 2005)

Concrete-lined Irrigation Canal
